**Pedestrian Evaluation Report  
System  
Hoddle Street Planning Study**

**Report ref:**  
205286  
28 July 2010  
Revision 2

Aurecon, as part of the Hoddle Vision Team, undertook a Pedestrian Evaluation Review System (PERS) audit along Hoddle Street, between Swan Street (Olympic Boulevard) and the Eastern Freeway.

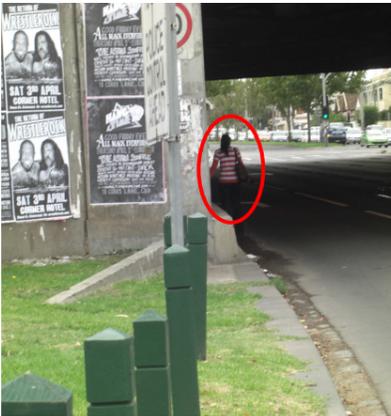
### Tunnel – western side

Pedestrians observed to walk in tunnel along western side. No footpath provided for pedestrian desire line from Olympic Boulevard to Brunton Avenue.

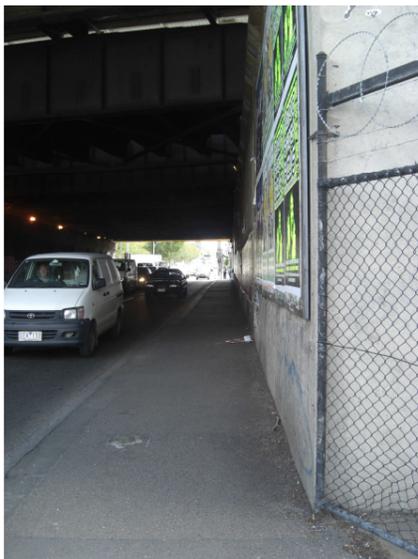
### General tunnel conditions

This was especially the case under the bridge at Richmond Station, in proximity to Swan Street, where the atmosphere was congested with fumes, poorly lit and heavily graffitied.

Conditions within the tunnel are extremely poor. Footpath width appears to be insufficient. Dim lighting and graffiti / posters contribute to the poor conditions.

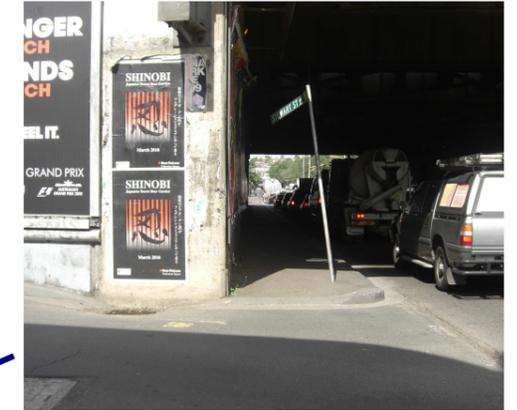
### Stewart Street / Punt Road intersection

Pedestrians are vulnerable at this crossing as vehicles turn into Stewart Street at speed. No tactile pavement is provided.

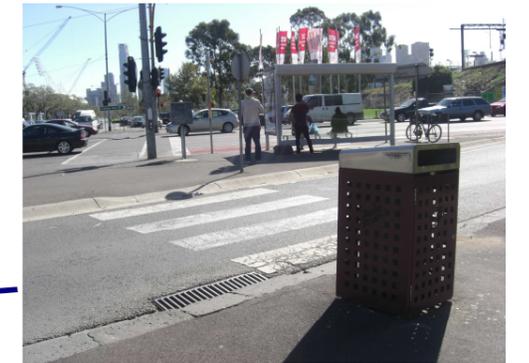
### Swan Street / Punt Road intersection

No tactile pavement is provided. Vehicles were observed to queue across zebra crossing. Bus stop is located within traffic island.

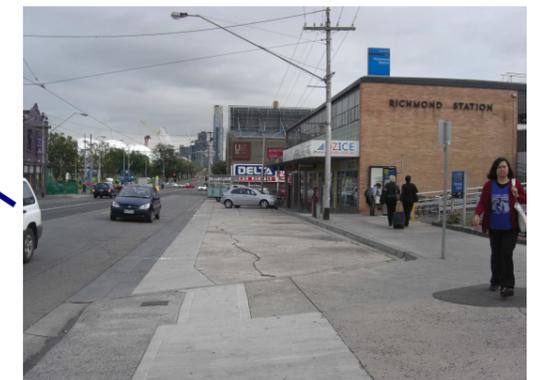
### Swan Street

Pedestrians have poor sightlines due to parked cars and path alignment. Minimal lighting is provided.

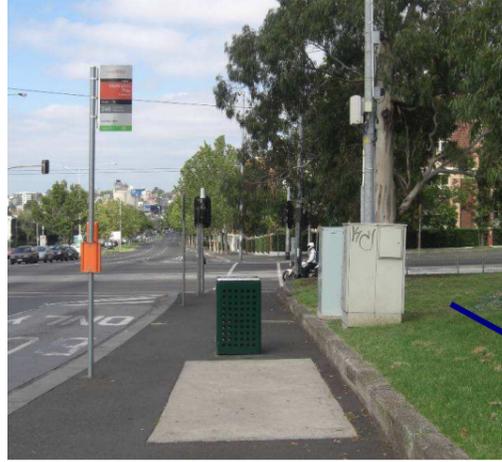
### Public transport waiting area

There are no pavement tactiles, shelter and seating provided at this bus stop. A bin is also located in the centre of the footpath

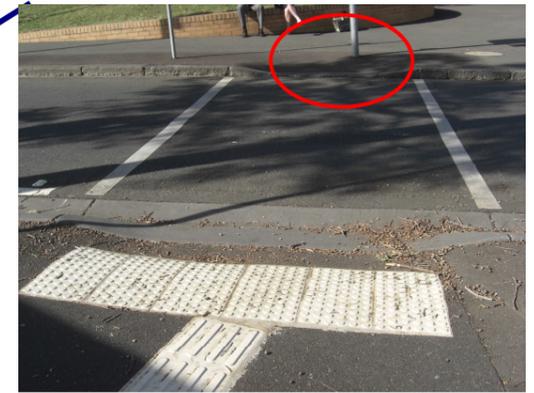
### Tactile pavement

Inconsistently coloured and provided. Poorly maintained with debris present.

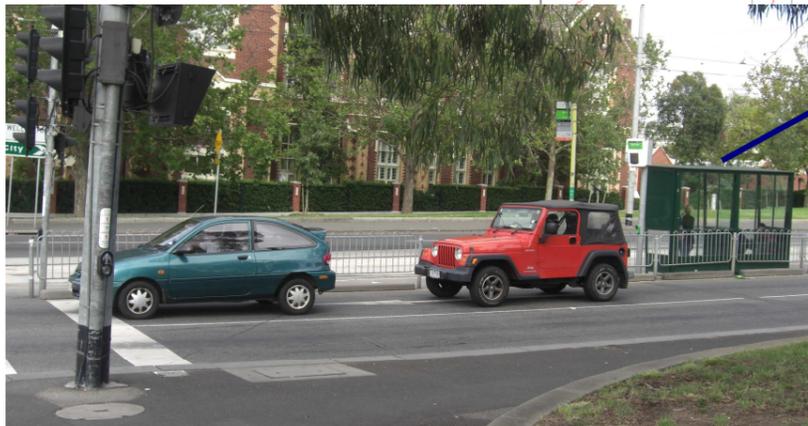
### Tram stop

Example of the better performing public transport waiting areas, where shelter, seating and real time information is provided

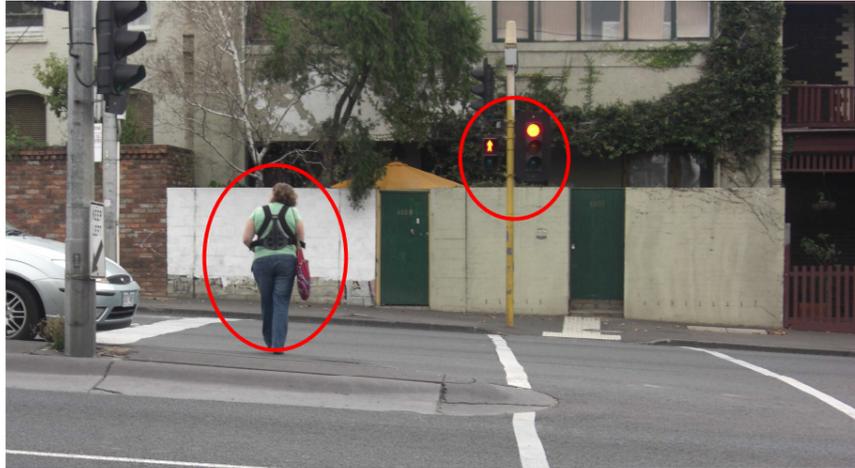
**Informal crossing**  
Pedestrian crossing against red man, away from provided crossing path

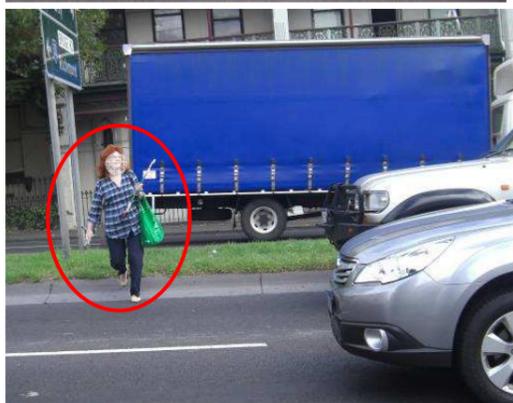
**Informal crossing**  
Located approximately within 200 m of a signalised crossing on either side. Due to delay and queued traffic, pedestrians (including man with a pram) elect to cross over kerbed median and weave through stationary traffic

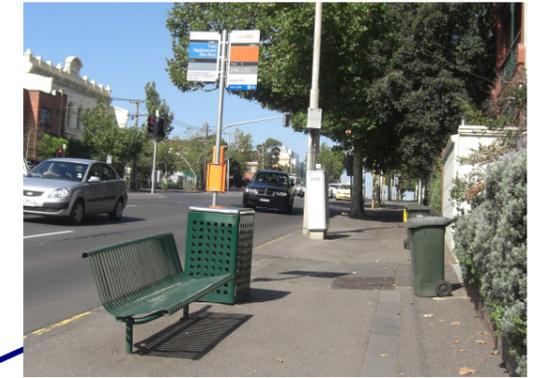
**Public transport waiting area**  
No shelter is provided. Lack of tactile pavement, which leads to confusion where passengers are to be picked up and dropped off

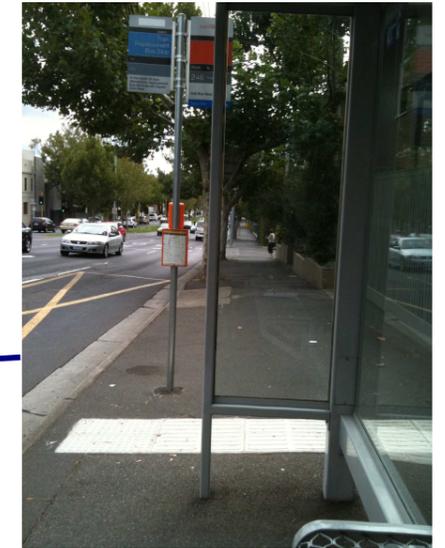
**Public transport waiting area**  
Edge of shelter located close to edge of traffic lane. Pedestrians walking through at this point may feel uncomfortable, due to proximity of fast moving traffic

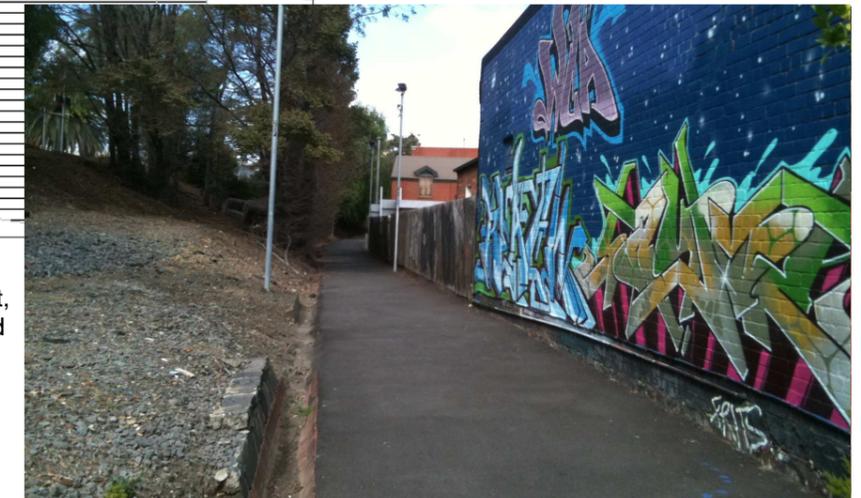
**Route**  
Poor access to the station. Closed environment, lack of activity with no passive surveillance and minimal lighting

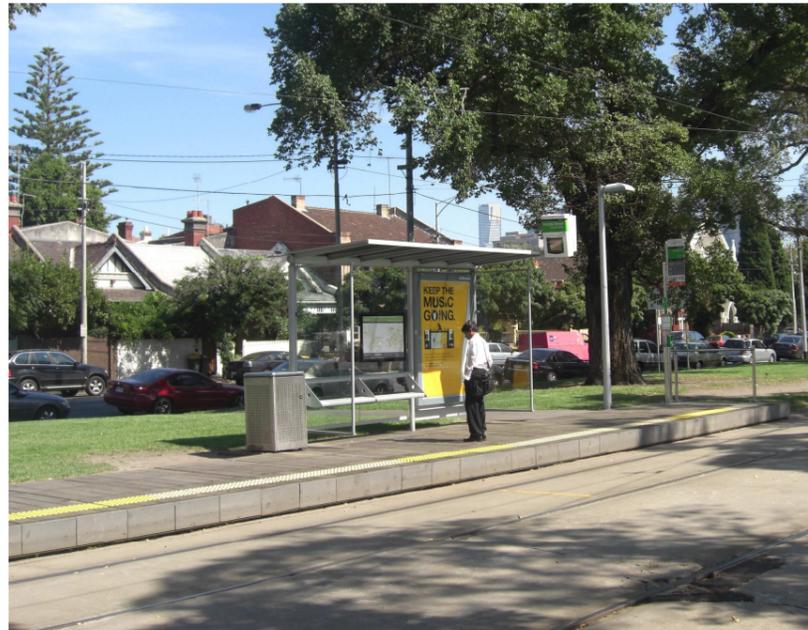
### Tram stops

Shelter, vagrant proof seating, bins and real time information provided at these tram stops

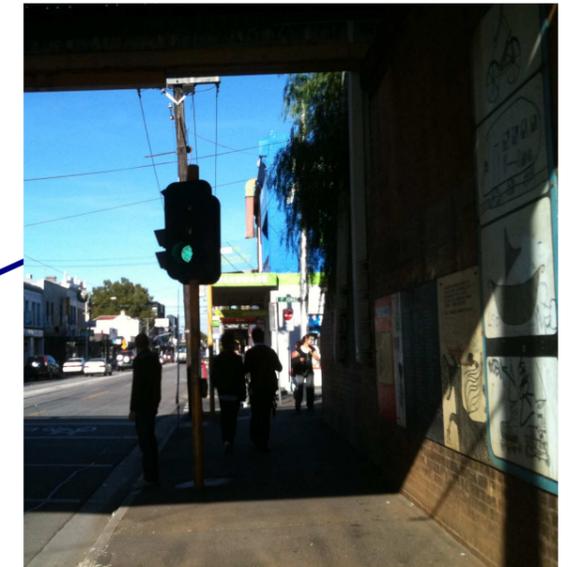
### Tram stop

Poor lighting and heavily graffitied walls provide an uncomfortable public transport waiting area

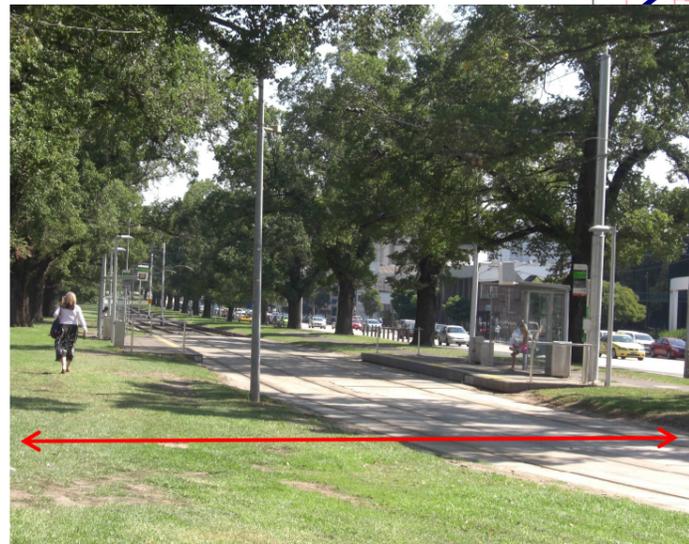
### Delay and crossing time

Due to the width of the median, which includes tram tracks, crossing time across Victoria Parade feels excessive. Poor vehicle behaviour observed on site

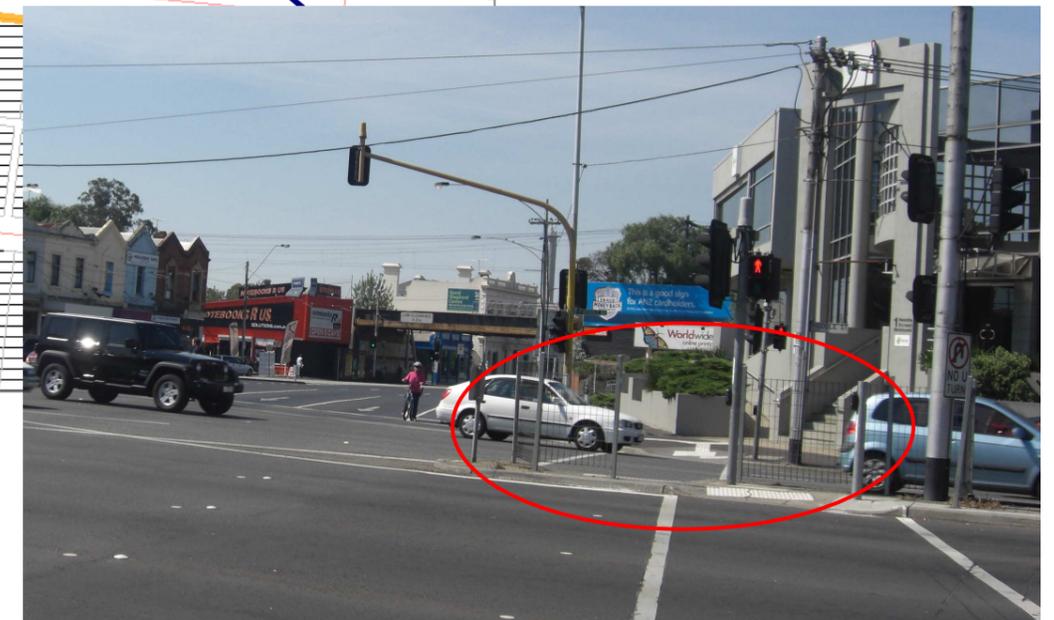
### Crossings

Crossings shown to perform generally well. Improvements to pedestrian fencing within the median can be improved. Also crossing across Hoddle Street is not aligned.

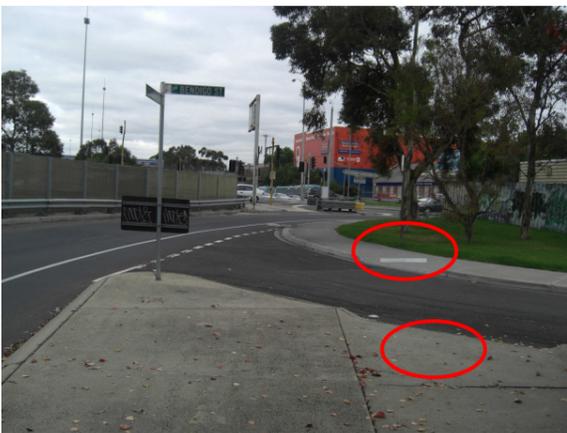
**Links**  
Below average pedestrian environment. Appears to be isolated, with inadequate tactile pavement provided

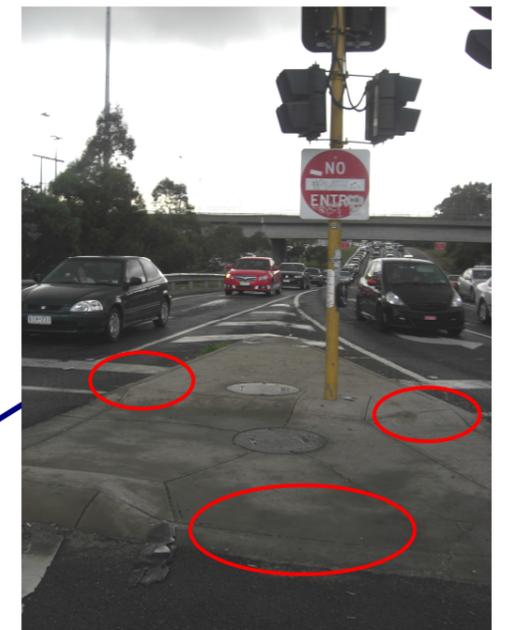
**Obstructions**  
Obstructions located within the median

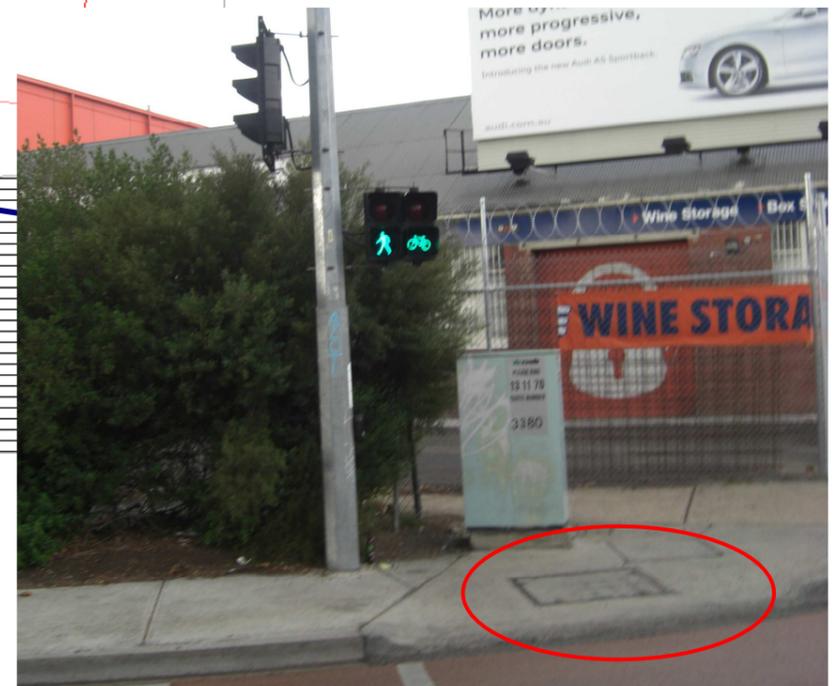
**Toucan crossing**  
Graffitied signal box, with shrubbery blocking pedestrian views of oncoming traffic. Proximity of bus lane leaves pedestrians feeling vulnerable, as buses observed to hug the road quite closely
